Archaeology on fire. Remote sensing based approach for the damage analysis: the case of Ventarron in Peru

EARSeL
REMOTE SENSING OF FOREST FIRE
DATA, SCIENCE AND OPERATIONAL APPLICATIONS
3-5 OCTOBER 2019

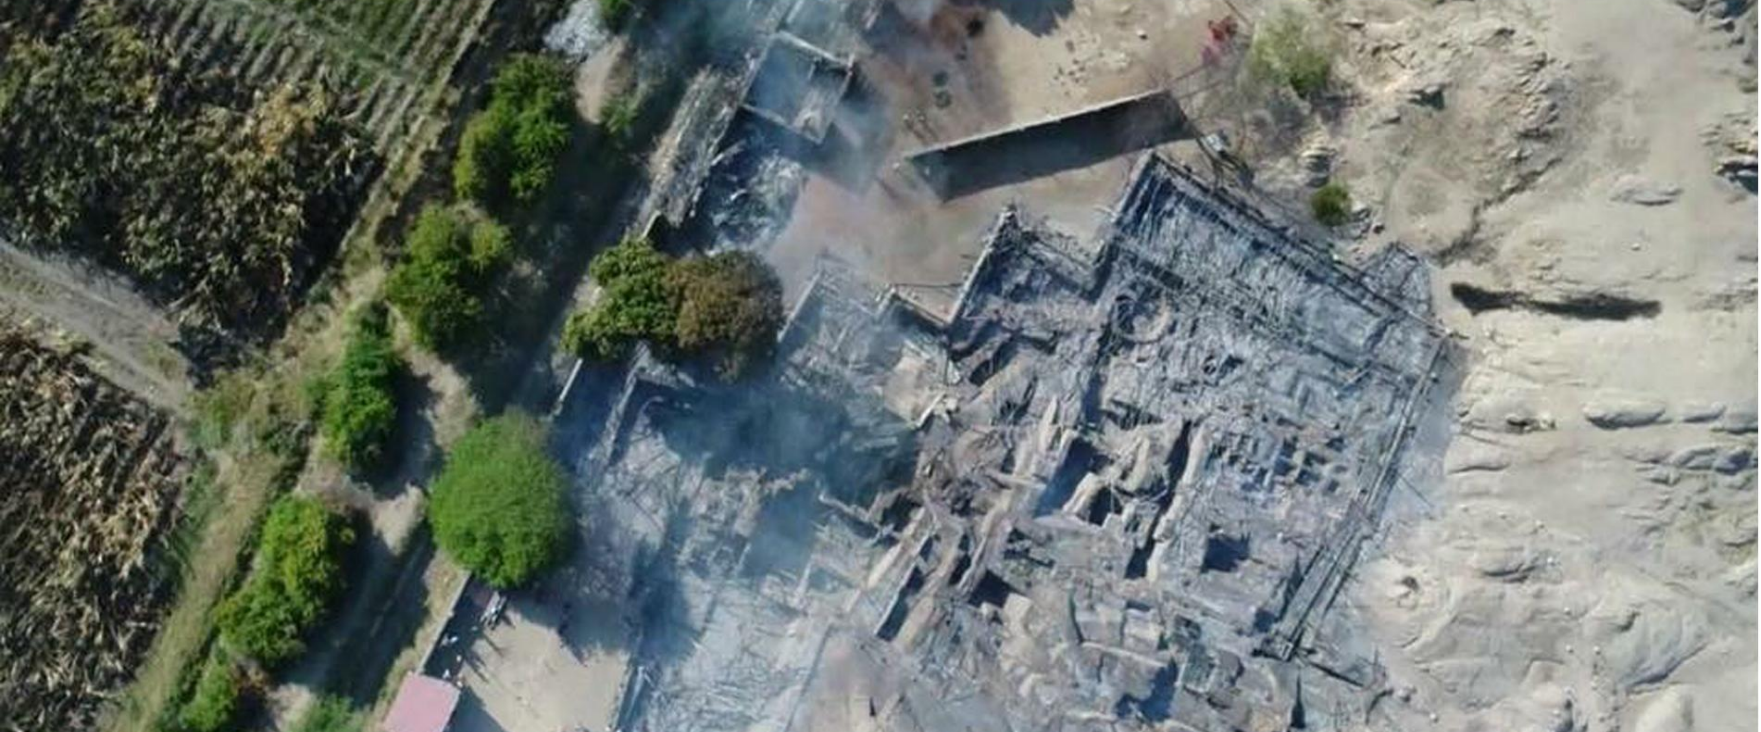
Fig.5 (a-d) Satellite multitemporal data set; (e) aerial image taken from drone (courtesy by Ignacio Alva)

Remote and proximal sensing tools, from satellite data to images acquired from drones, could help to identify responsibilities, destructive dynamics of the event, possible errors in the management of agricultural fields. With such regard, the multitemporal data set (figure 5 a-d) available from Google Earth evidenced that before 2016 March (figure 5a-b), the area where the fire started, was not cultivated and characterized by sparse herbaceous cover, with a (conscious or unaware?) function of firebreak. From March 2016 up the fire event the plot of land adjacent the archaeological site was covered by cultivations (figure 5c), eliminating the fire cut function that probably would have made the fire less destructive.

Ground documentation, drone flights and satellite acquisitions showed that the fire was caused by the burning of weeds of a sugar company in the contour of the fields, adjacent to the archaeological monument. The fire began as part of the regular work of burning fields. It was also found that the burning of weeds was not controlled and spread for more than 200 meters in favor of the wind. The fire in its uncontrolled route reached the roofs of the warehouses located on the west side of the archaeological site. Immediately afterwards, the fire spread rapidly and became uncontrollable due to the flammable nature of the material used on the roof covering the archaeological structures (bituminous tablet, Onduline, plastic plates of Fibraforte). In particular plastic material, once burned, melted on the most important murals and architectural components, with heavy damage to pictorial layers and walls. The Peruvian Ministry of Culture announced an official investigation to determine who was responsible for the fire.
